USACERL Technical Report 95/02
May 1995

Thermal Energy Supply Optimization for Aberdeen Proving Ground-Edgewood Area

Distribution System Condition Assessment and Recommendations

by
Vicki L. Van Blaricum, Charles P. Marsh, and Vincent F. Hock

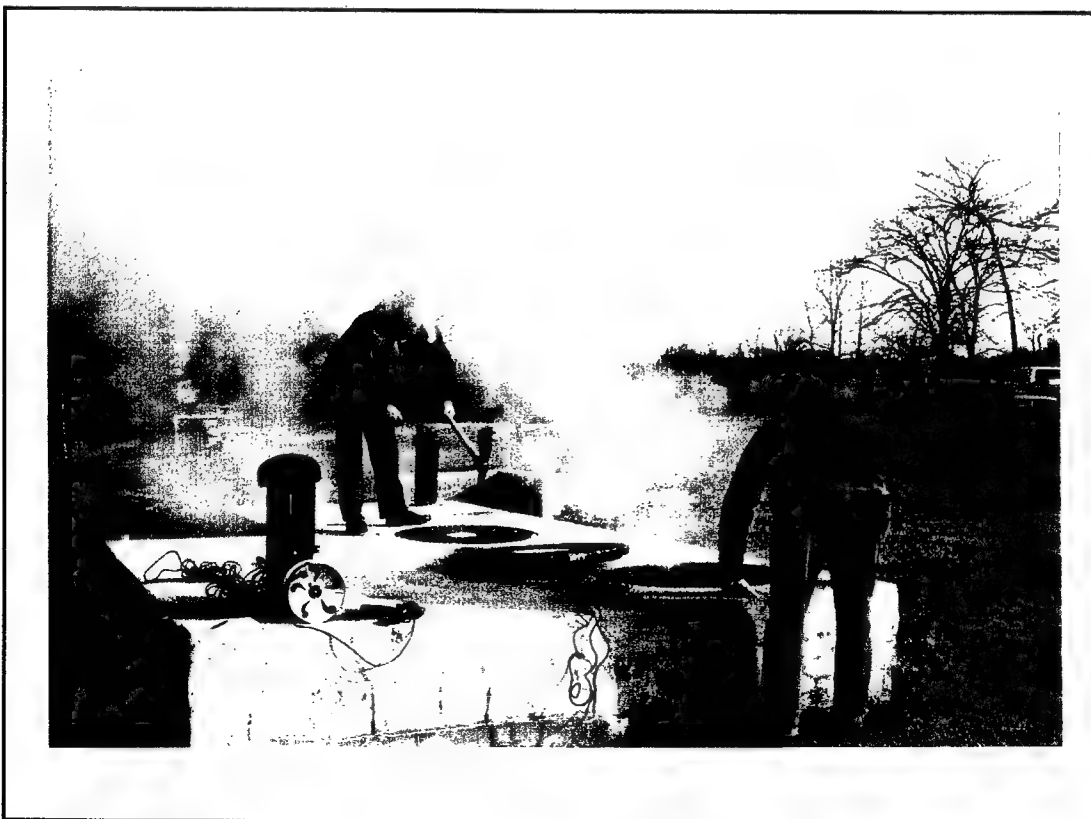
Figure 15. Typical steaming manhole (no. 5220) with standing water.

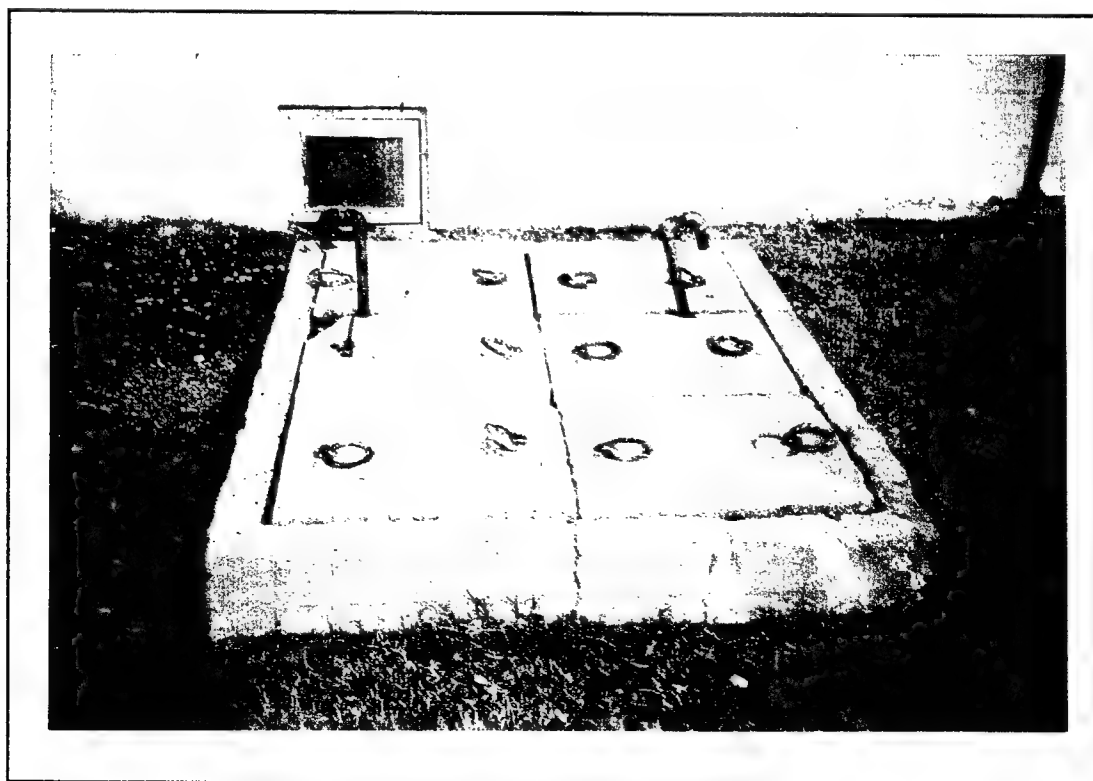
One manhole with an excessively heavy concrete manhole cover was observed (Figure 22). Such manhole covers make it very difficult to perform maintenance or inspections in the manhole.

Figure 22. Excessively heavy concrete manhole cover in the 4000 area.
